Manhole Inspection Summary

Manhole # S43SS_009MH

Location Address: **1628 MONTPELIER ST**

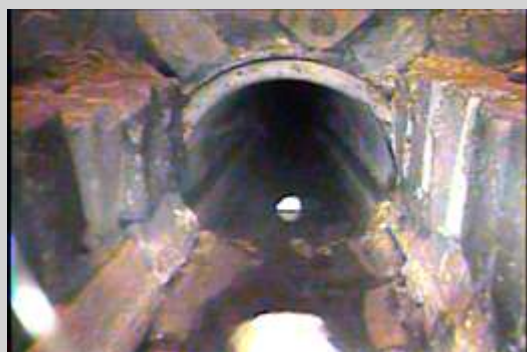
Pipe In @ 6 O'Clock

8 in. Circular Gravity Sewer

Pipe Material: **Clay** ☐ Pipe Lined

Infiltration: **None** Pipe Seal Cond: **Unknown**
